Macleay River Water Quality Monitoring Project.

This is a copy of a Paper prepared by Mike Dutton, on behalf of Kempsey Shire Council, for the Institute of Municipal Engineering Australia Award in 1999

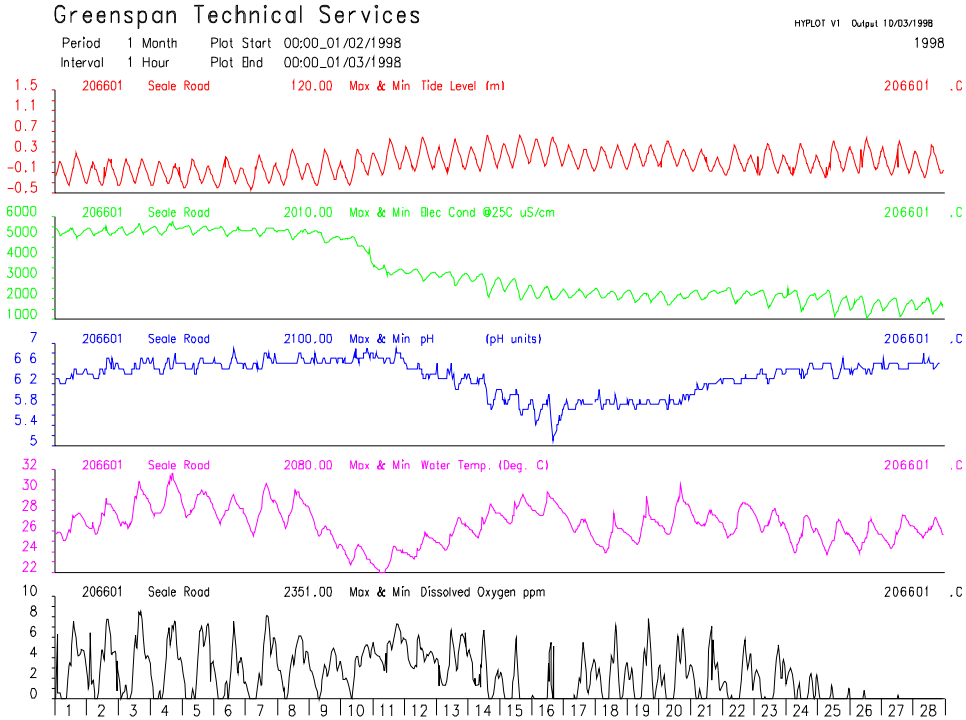
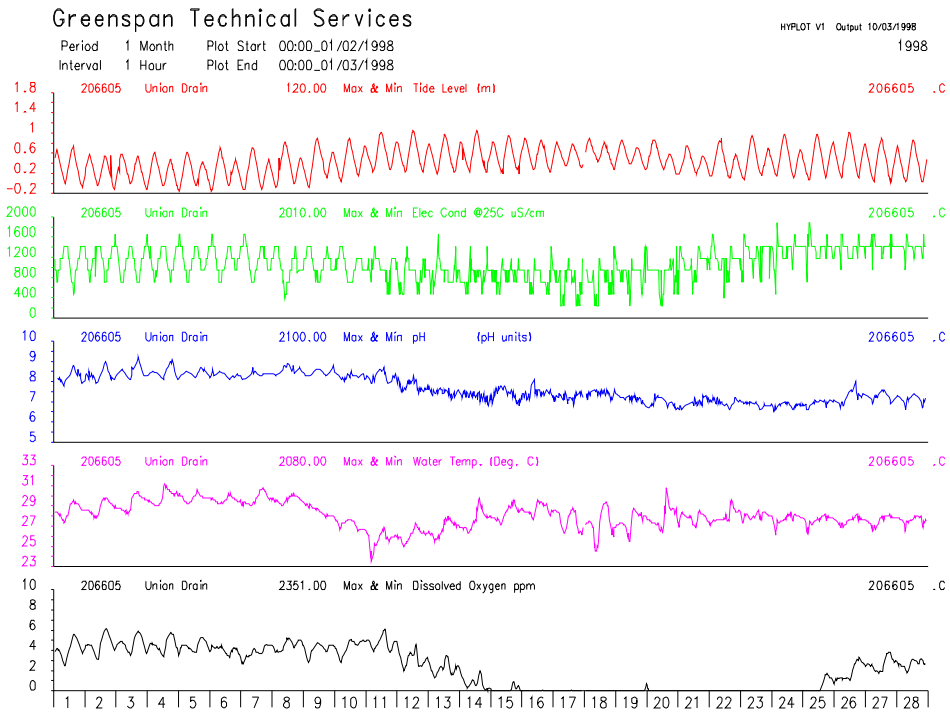
APPENDIX A

Typical graphed results of water quality monitoring in Belmore River, upper and lower reaches.

Results to date in the Belmore River indicate a strong variation in quality over its length. Following the mid-February flood the river was very turbid (chocolate brown) for about three months. This is apparently due to high iron and low oxygen content and the sediment load retained in suspension. A brief analysis of the results can be made by dividing the river into upper and lower reaches, divided by the flood headworks. (*See Appendix A for graphed results*)

In the lower river following the flood, DO levels were almost zero and constant, Ec was less than 200 uS/cm (ie fresh water) and pH between 5.5 and 6.0. Tidal action was noted to affect pH and Ec but not DO. Incoming tide caused pH and Ec to raise with a corresponding fall as the tide ran out. While DO remained very low until May, pH gradually fell and Ec gradually increased as the water cleared and tidal flushing was more effective.

In the upper river, DO increased more rapidly with time (from zero in March to 5.0ppm in late April) while pH increased gradually to 6.2 and Ec climbed to 3000 uS/cm in a month. In this area tidal variations were more noticeable and it was apparent that there is a salt source. At low tide the flap on the Scott's Drain opened and discharged water with higher DO and salinity into the Belmore River. Acidity (pH) also changed with the tidal outflow, however it appeared this was being buffered by the salinity.

In June, in the lower river (Union Drain), pH had settled between 5.0 and 5.5, DO around 10ppm and Ec around 2000uS/cm. In the upper section pH was less than 4.0, DO was 5.5 and Ec was about 1400. These results would appear to be typical for the Belmore River in normal conditions. Some changes occur with very hot temperatures and in extremes of tide. Readings of pH down to 2.9 and Ec up to 18,000 have occurred at Scott's Drain.
